Mel Price-Wood River Problem Seepage Area Background

Wood River D&LD - Upper

Presented by: Ryan Goetz, P.E. (USACE)

Date: 11 November 16

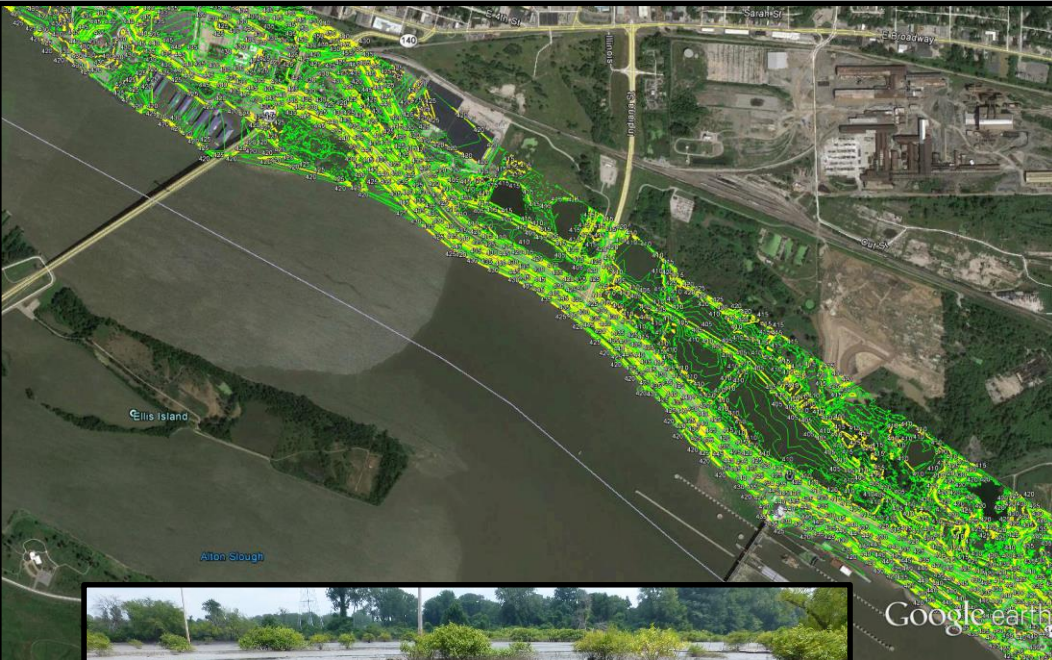
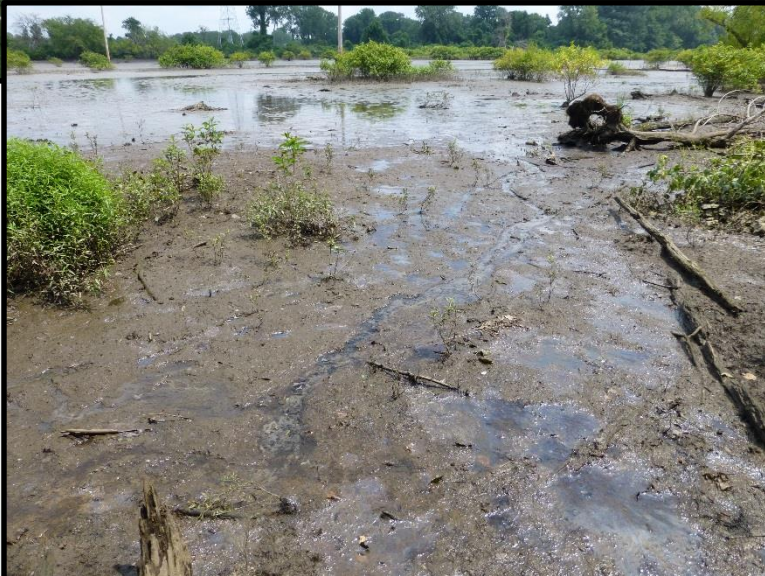
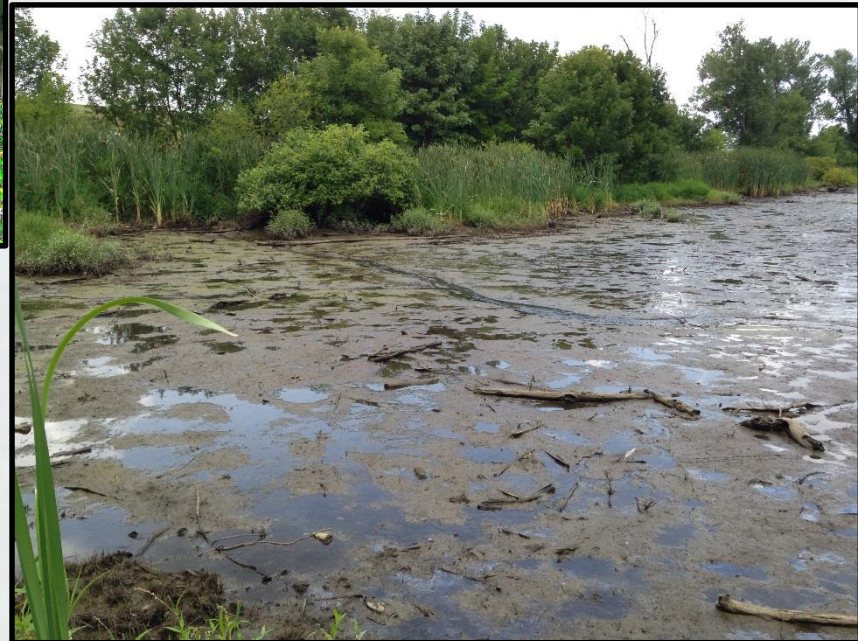
Problem Discovery – 2009

- Data Gathering to refine LIDAR information
- Discovered clear flowing seepage

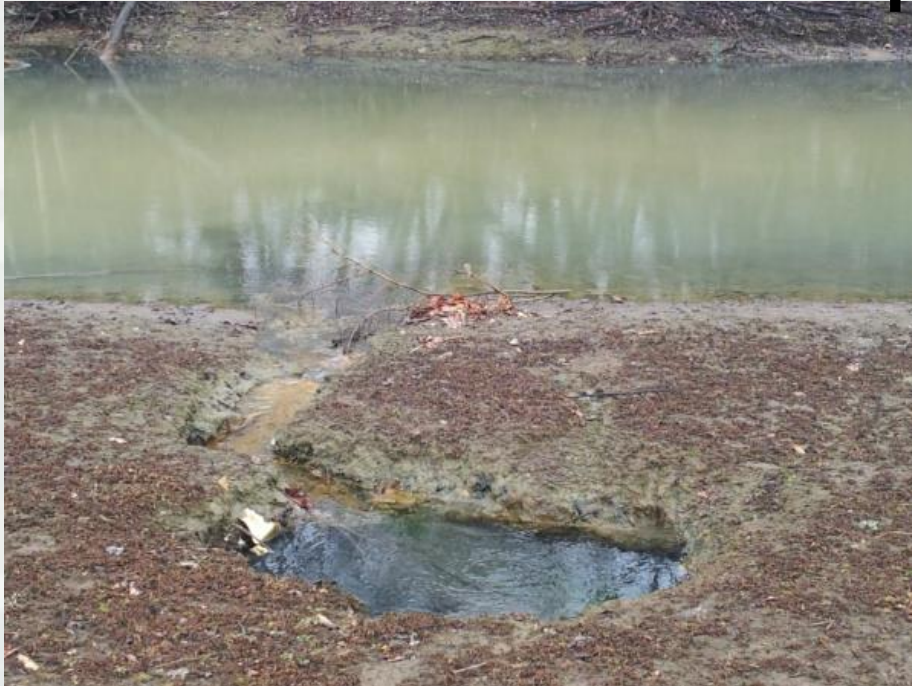
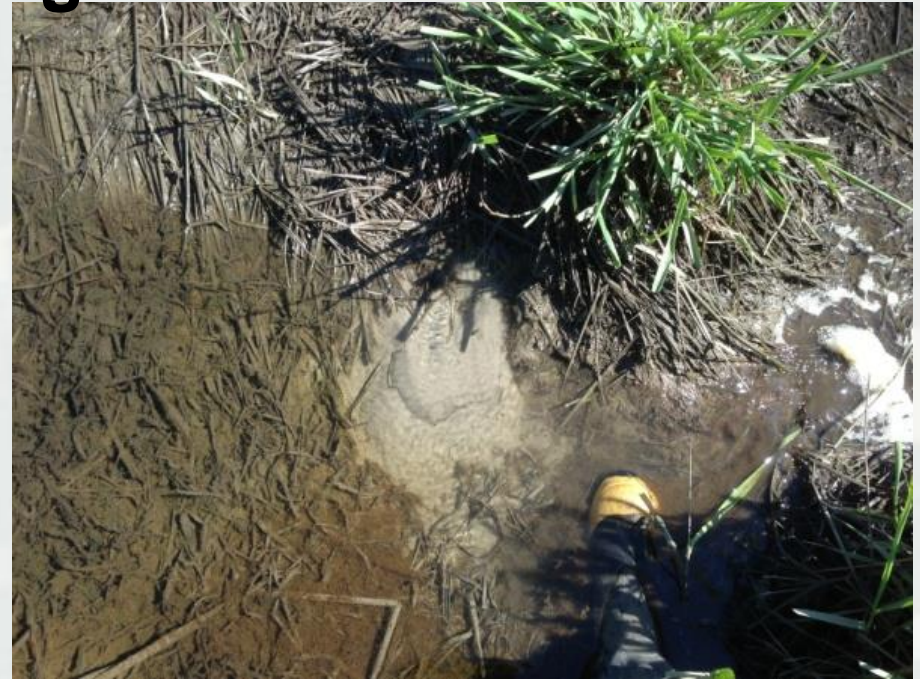
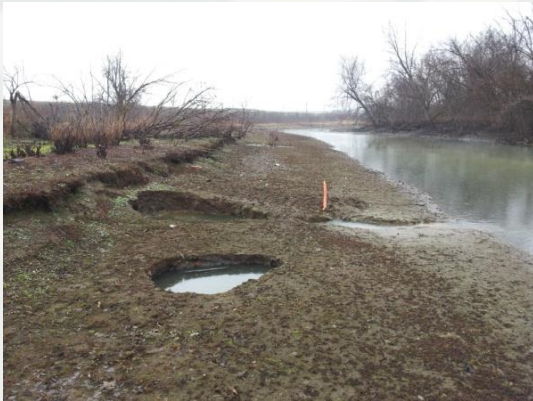
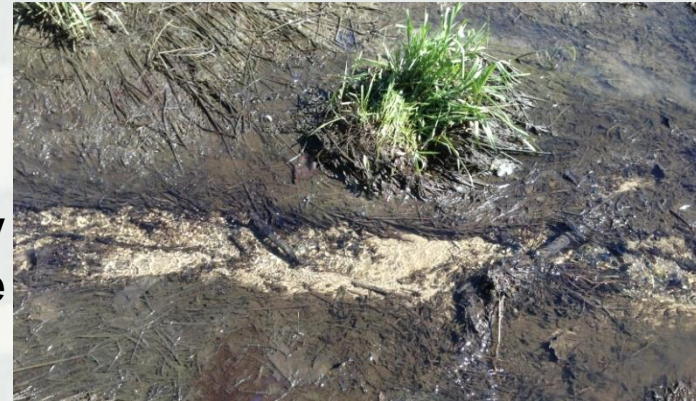
Problem Discovery – November 2009

Uncontrolled Seepage and Sand Boils

Ongoing Uncontrolled Seepage and Sand Boils.
Caused by constant differential head created by normal pool at Melvin Price Locks and Dam.

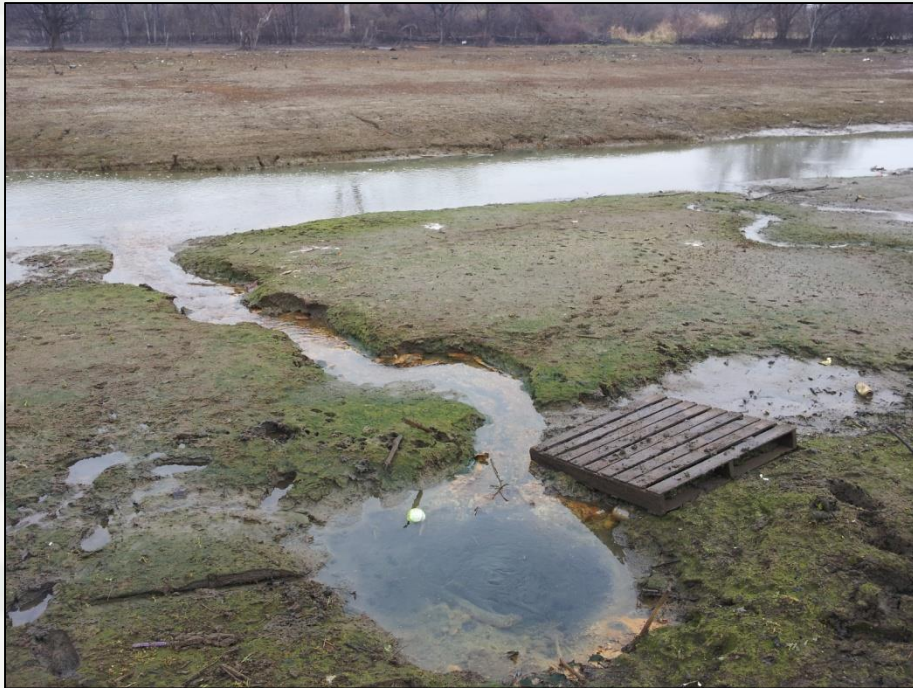
**Uncontrolled Underseepage
Creating a Sand Boil**

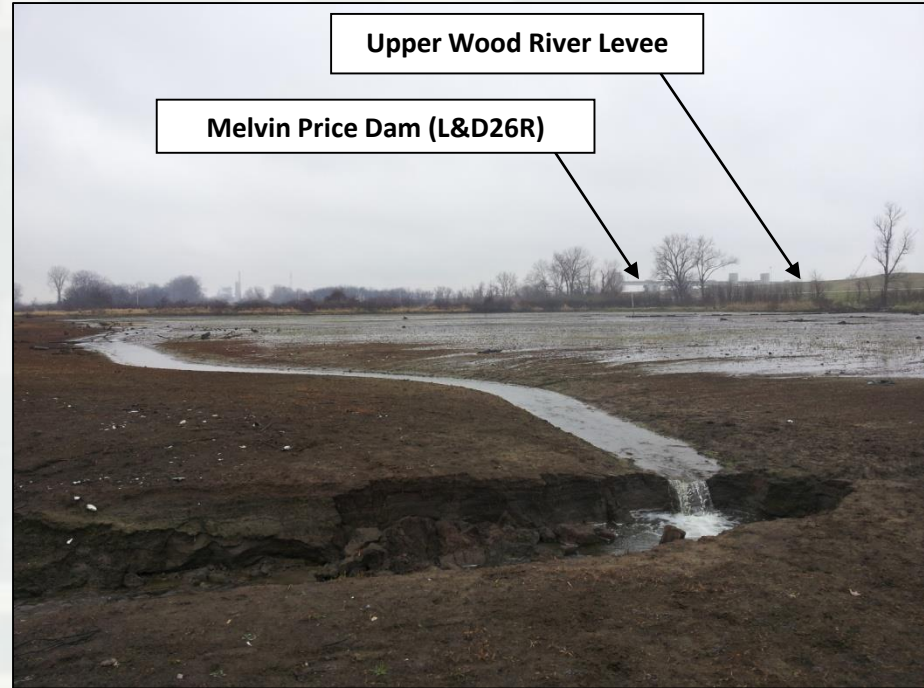
**Sheet flows of
Underseepage Collecting
and causing Head Cutting
Erosion**

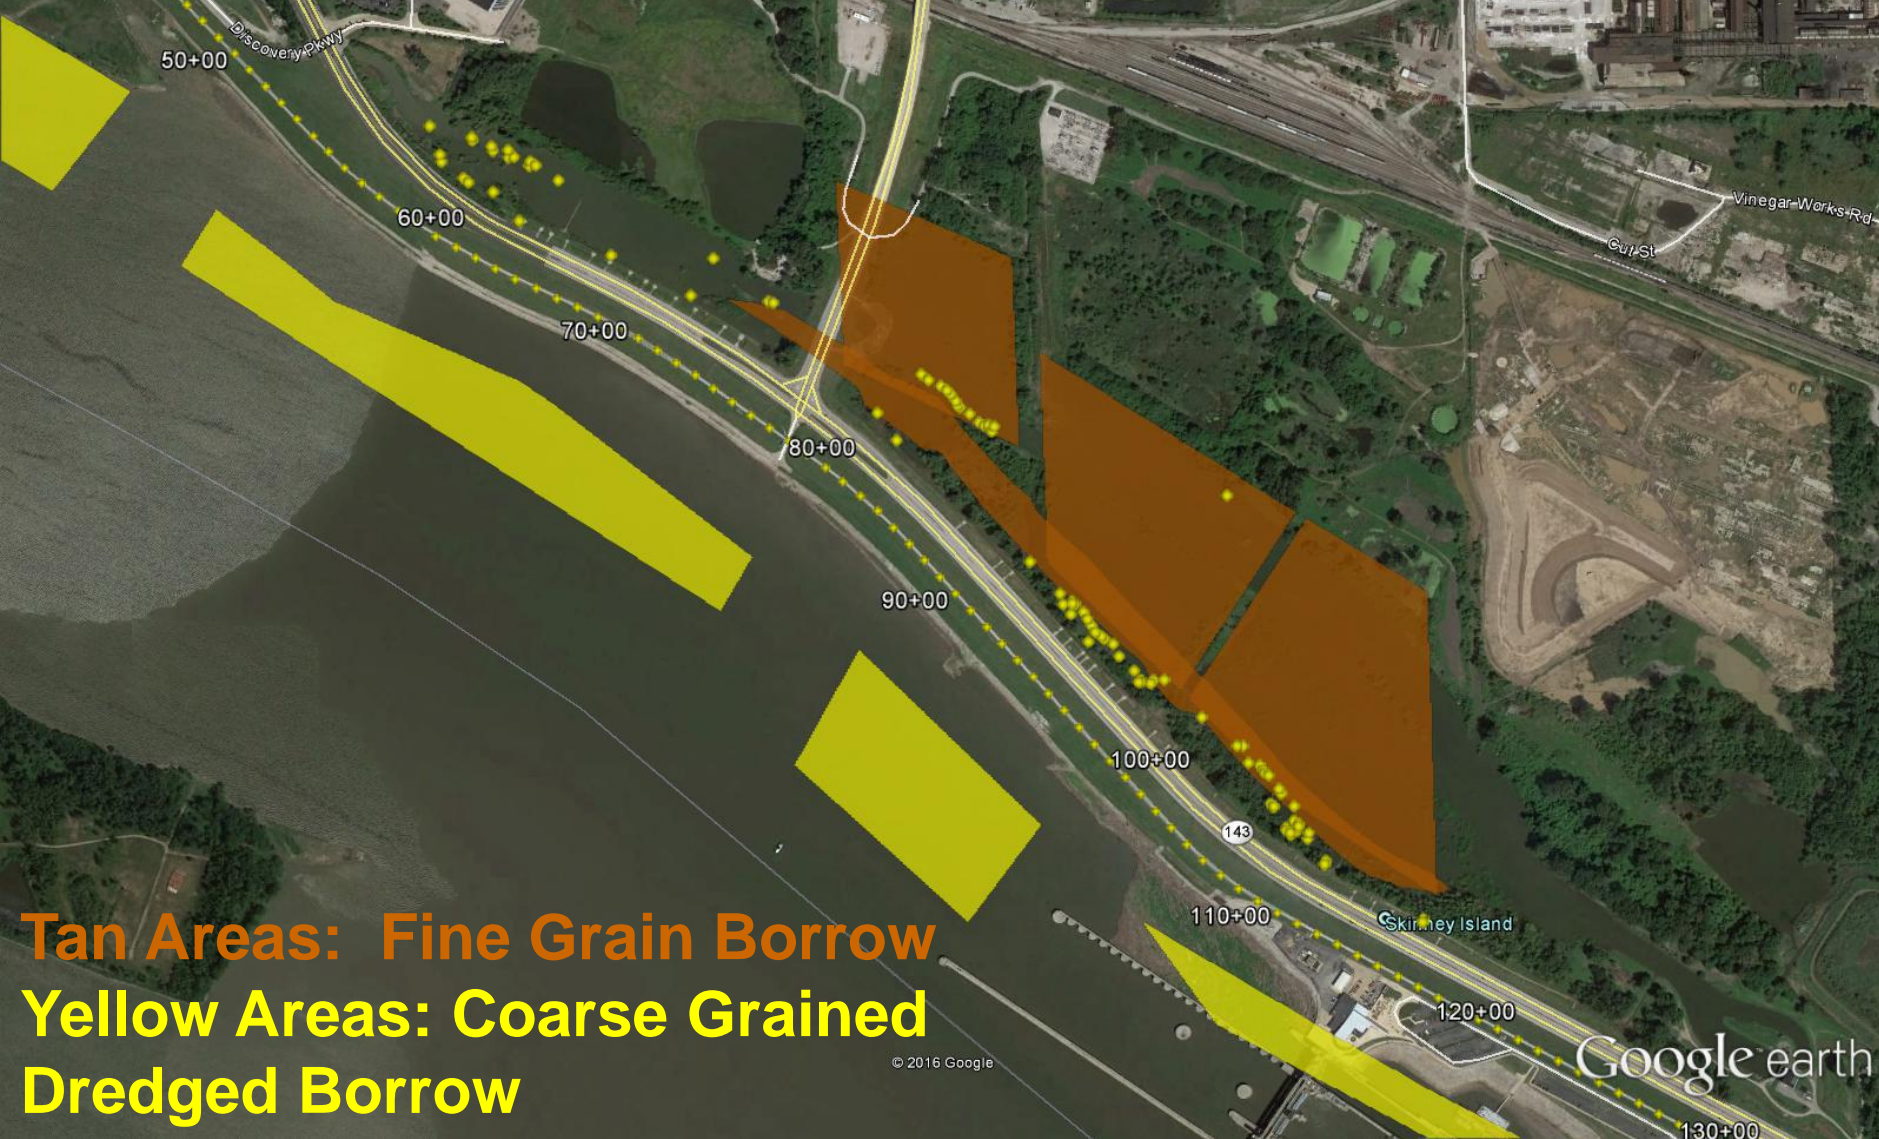
Borrow Locations with Seepage Location Overlaid

Tan Areas: Fine Grain Borrow
Yellow Areas: Coarse Grained Dredged Borrow
