Mel Price-Wood River Problem Seepage Area Background

Wood River D&LD - Upper

Presented by: Ryan Goetz, P.E. (USACE)

Date: 11 November 16

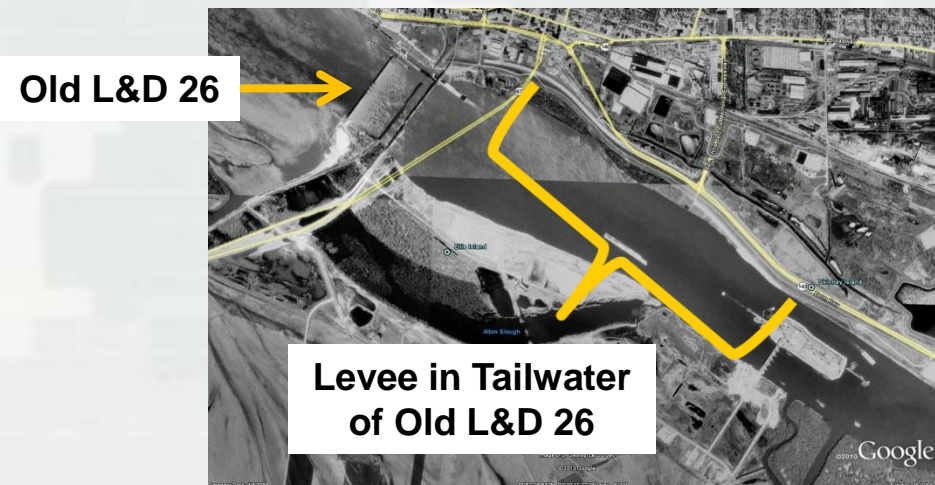
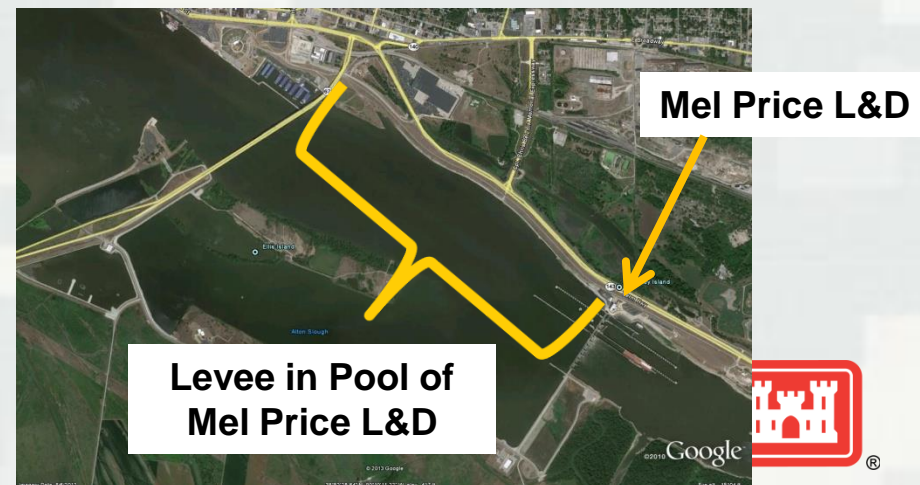
April 1988

- Relocation of old Lock & Dam 26 two miles downstream to Mel Price Locks & Dam caused a permanent pool to be placed on the Upper Wood River Levee from Sta 0+00 to Sta 115+24.

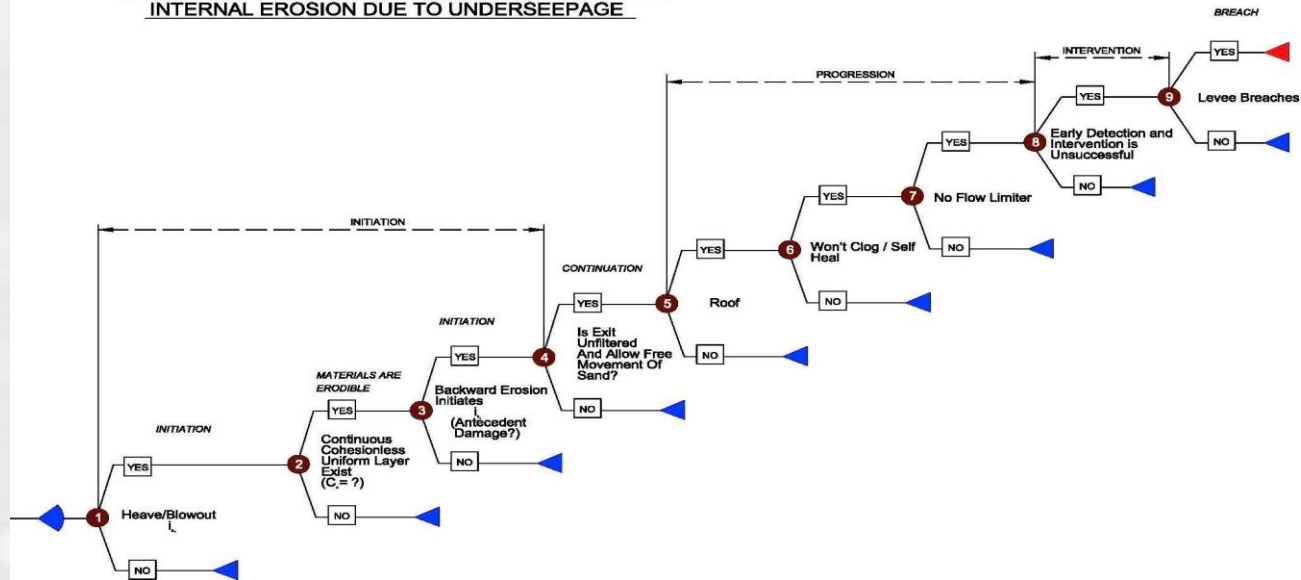
Failure Event Tree – Internal Erosion Due to Underseepage

INTERNAL EROSION DUE TO UNDERSEEPAGE
 (FLAW) A COMBINATION OF THE DEFECT/FLAW EXISTS WHICH COMPROMISES THE CONFINING LAYER WHICH PROVIDES A PATHWAY/CRACK THROUGH THE CONFINING LAYER.
 (UNFILTERED EXIT) BACKWARDS EROSION CAN CONTINUE BENEATH THE CONFINING LAYER FOUND UNDER THE LEVEE WHICH IS CAPABLE OF MAINTAINING A ROOF.
 (INITIATION) A RAINFALL EVENT RAISES THE MISSISSIPPI RIVER LEVEL ABOVE LEVEE TOE WHICH CAUSES SATURATION OF FOUNDATION SAND. HIGH PIEZOMETRIC PRESSURE IS THEN TRANSMITTED THROUGH THE FOUNDATION TO THE LANDSIDE OF THE LEVEE. THE GRADIENT IS DEVELOPED AT THE BASE OF THE DITCH TO THE POINT WHERE THE CRITICAL GRADIENT IS EXCEEDED AND MATERIAL TRANSPORTATION IS INITIATED.
 (PROGRESSION) THE CRITICAL LOADING DURATION IS SUFFICIENT TO ALLOW BACKWARDS EROSION TO PROGRESS THE PIPE DIRECTLY UNDER THE CONFINING LAYER TOWARD THE RIVER.
 (BREACH) THE PIPE LEADS TO GROSS ENLARGEMENT OF THE PIPE AND COLLAPSE OF THE CLAY ROOF WHICH LOWERS THE CREST BELOW THE FLOOD LEVEL. THIS ALLOWS OVERTOPPING AND EVENTUALLY BREACHES THE LEVEE.

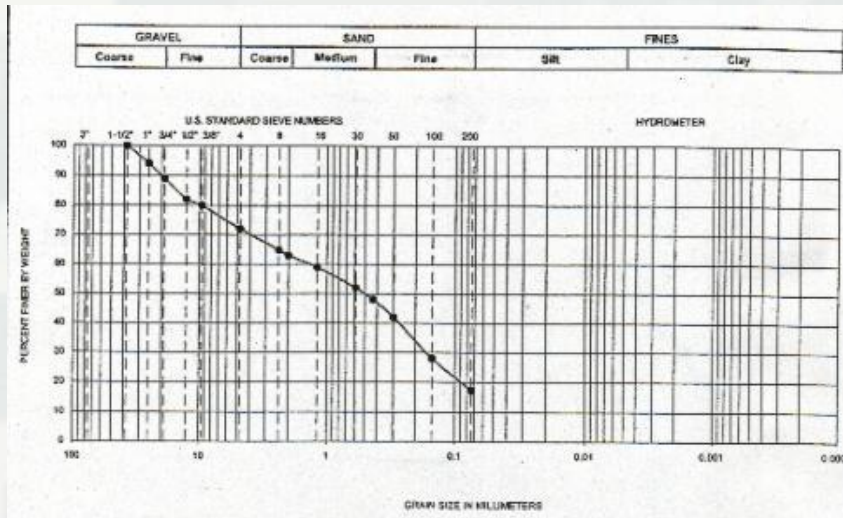
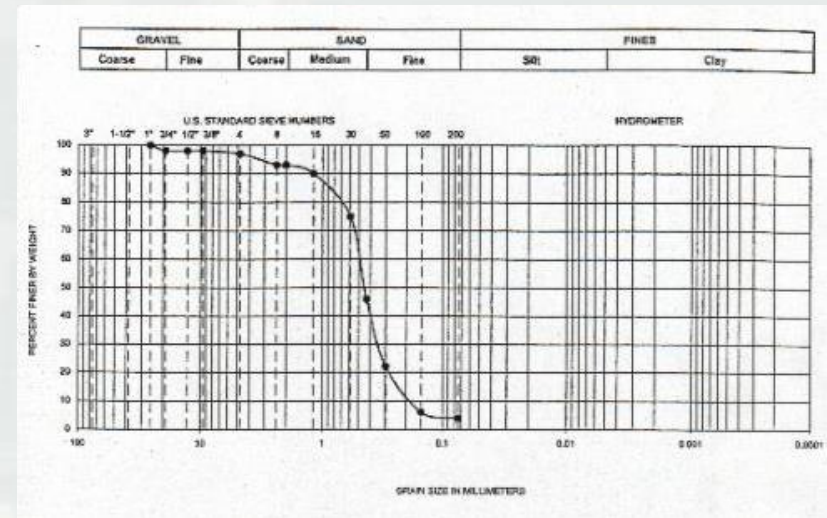
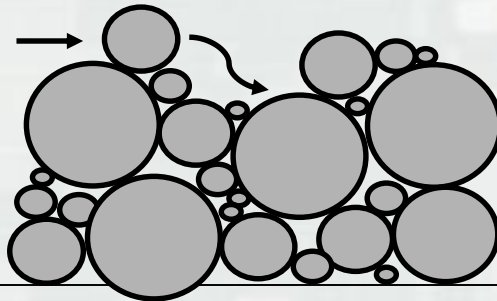
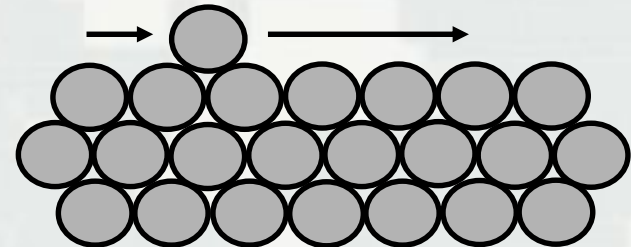
SW
Higher C_u

SP
Lower C_u

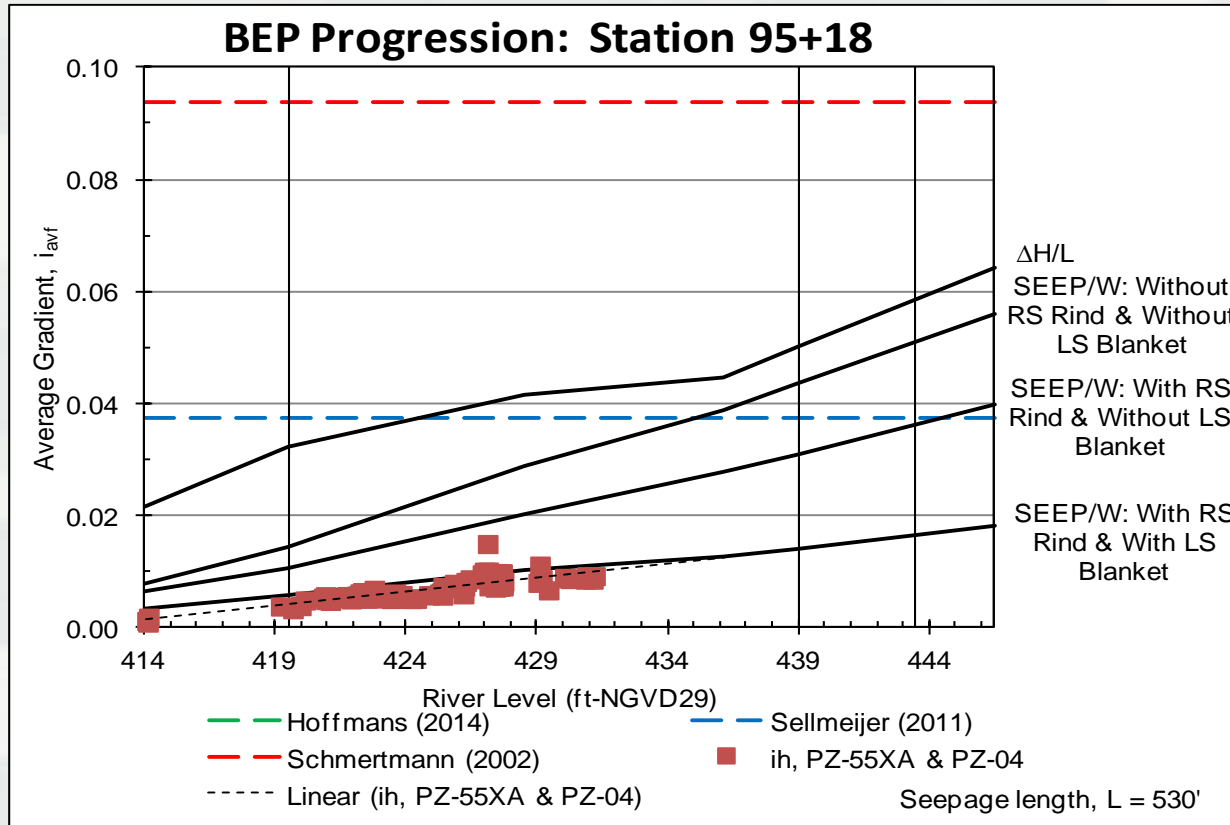
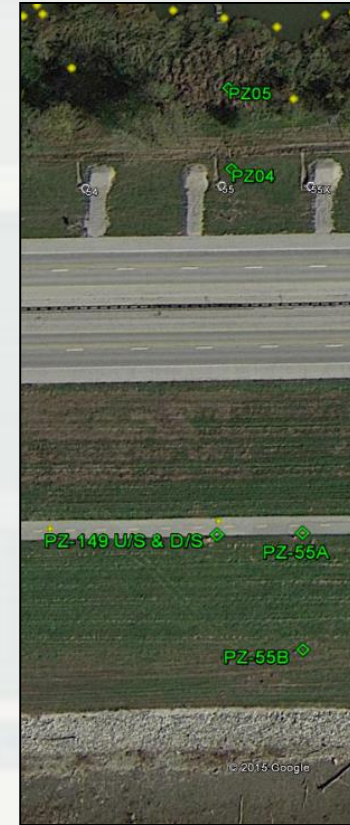
PFM 1 Node 3 - BEP Initiates

- Modeling results against critical
